**DRAFT FINAL  
EXPANDED ENGINEERING EVALUATION/COST ANALYSIS (EEE/CA)  
FOR THE  
McLAREN TAILINGS SITE  
COOKE CITY, MONTANA**

Engineering Services Agreement DEQ/MWCB 401027  
Task Order Number 05

Pioneer Technical Services, Inc.  
P.O. Box 3445  
Butte, Montana 59702

**May 2002**

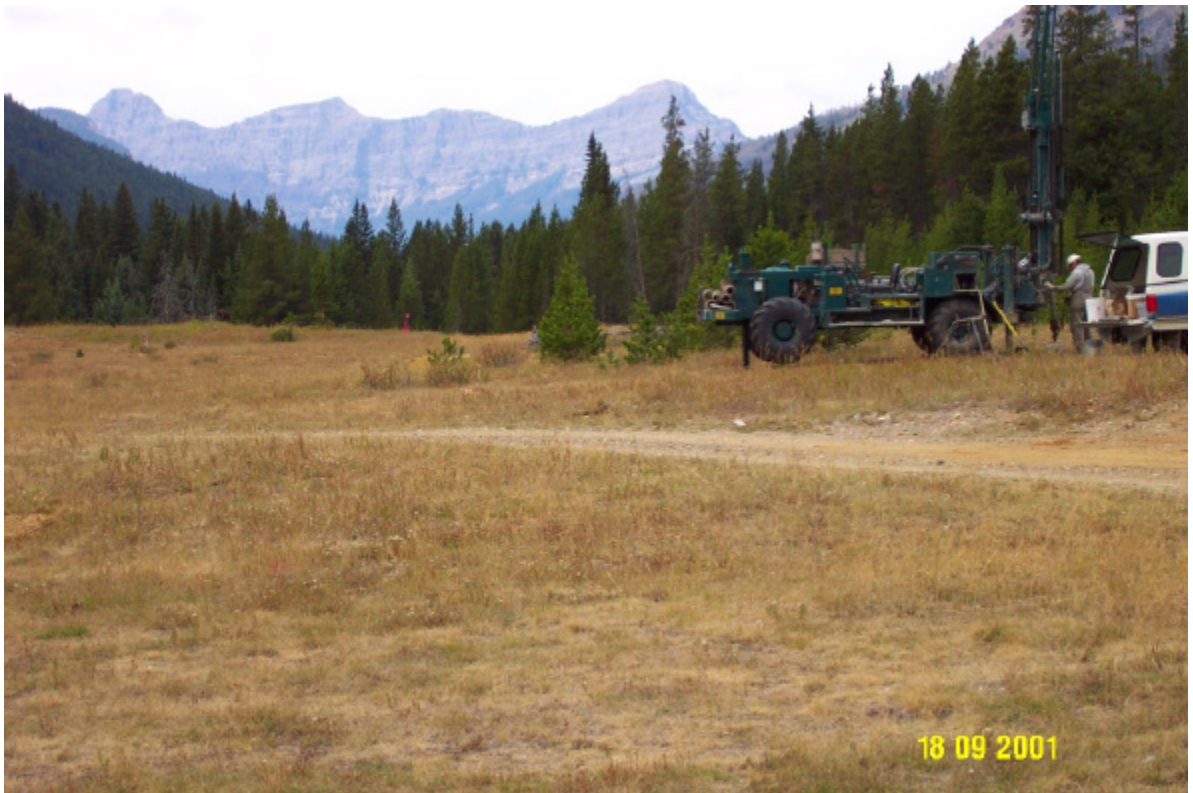
Photo 1: Boring #1, view is toward the west. Impoundment dam is visible in left background.

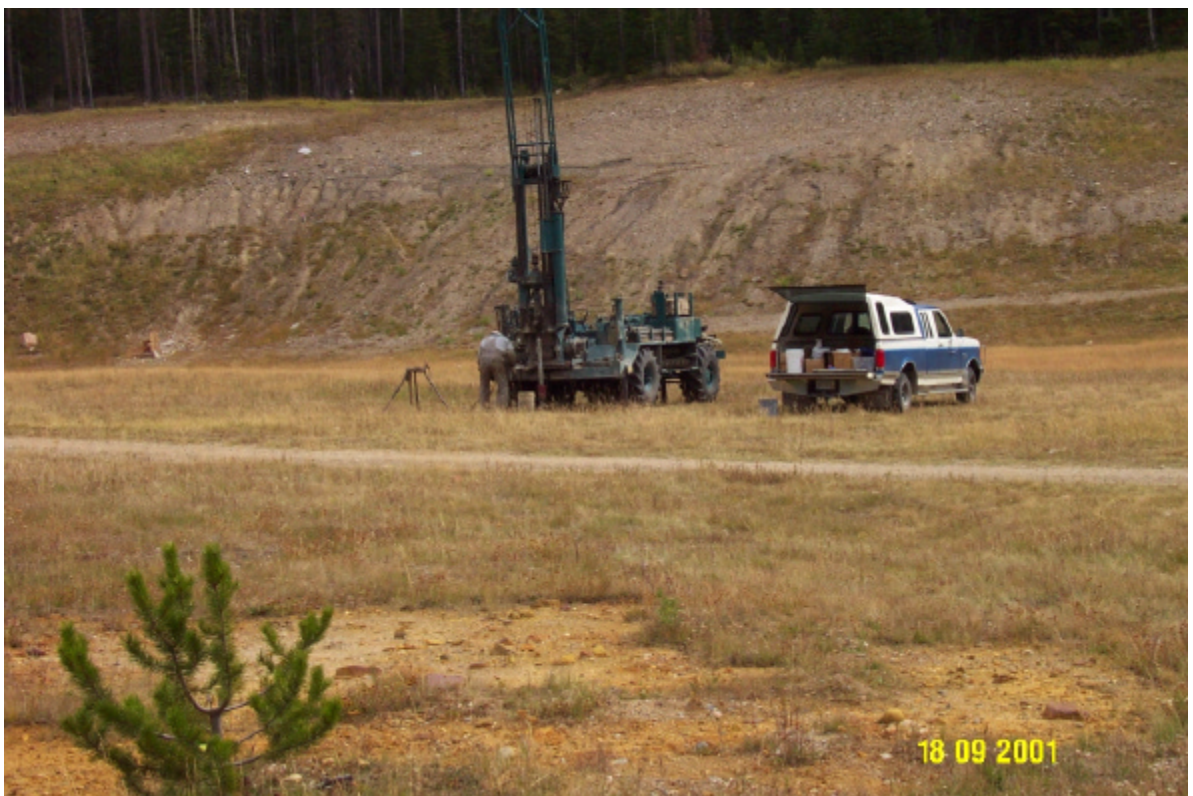
Photo 2: Boring #2, view is toward the east. Borrow area for 1990 toe berm construction is in background.

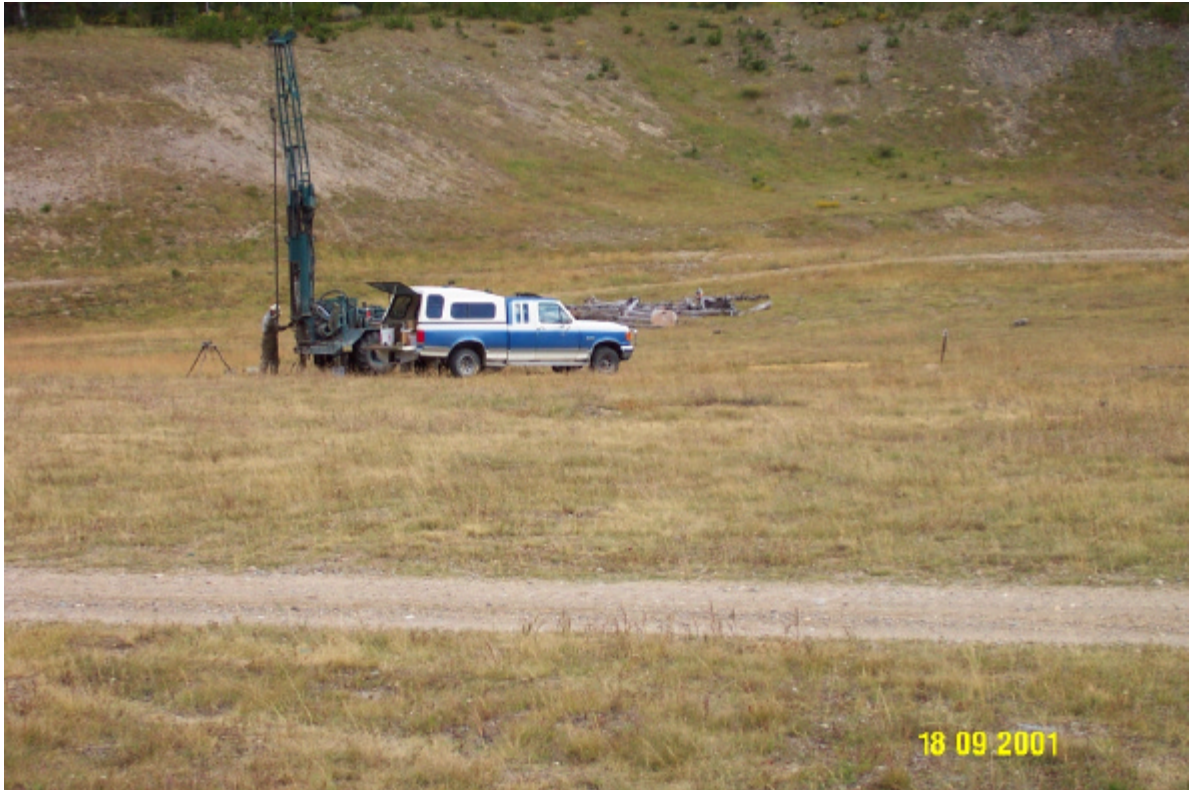
Photo 3: Boring #3, view is towards the southeast. There is a cluster of monitoring wells in this area.

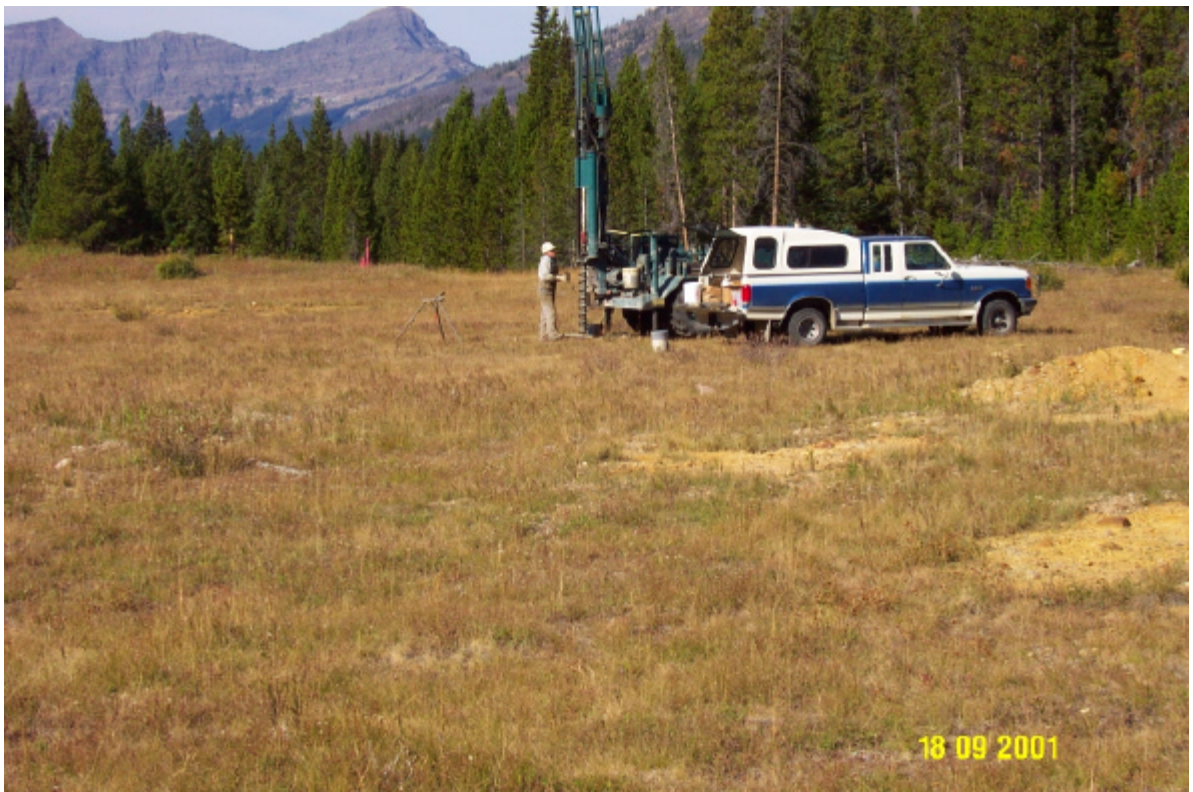
Photo 4: Boring #4, view is to the northwest. Northern end of impoundment dam is visible in left background.

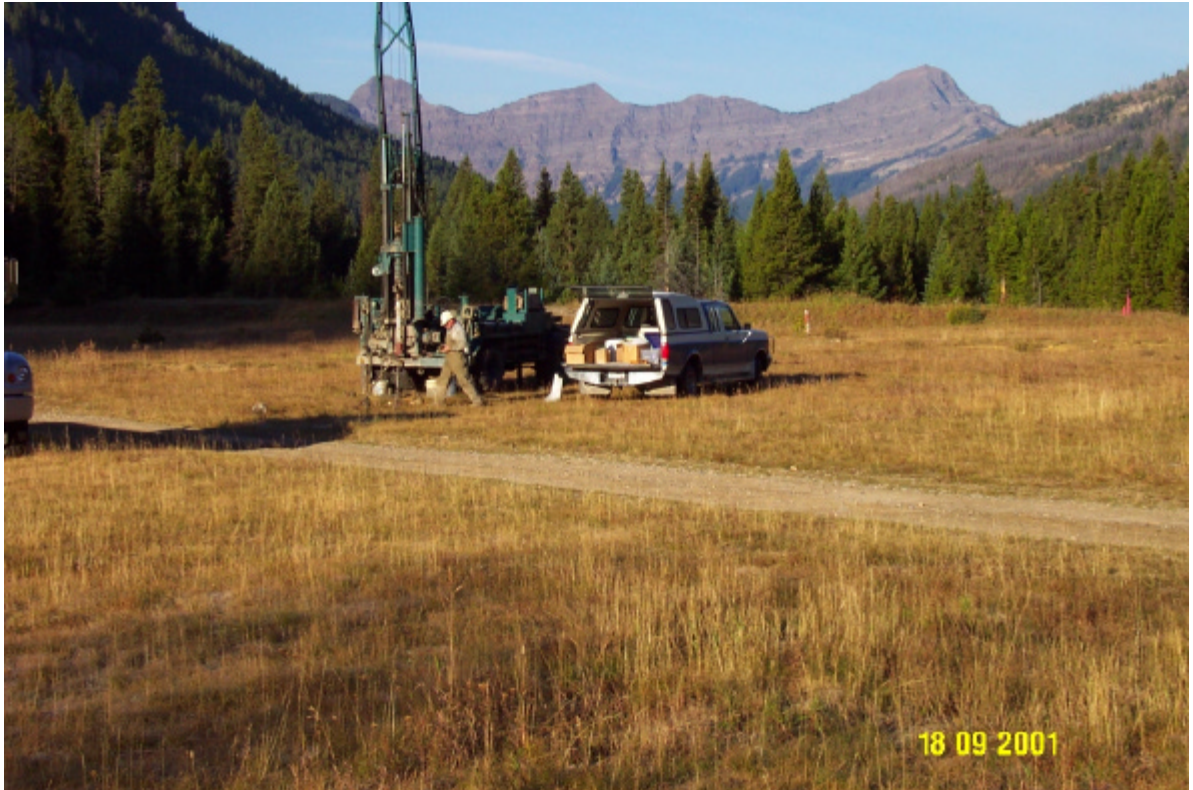
Photo 5: Boring #5, view is towards the west. The impoundment dam is visible across the front of the trees.

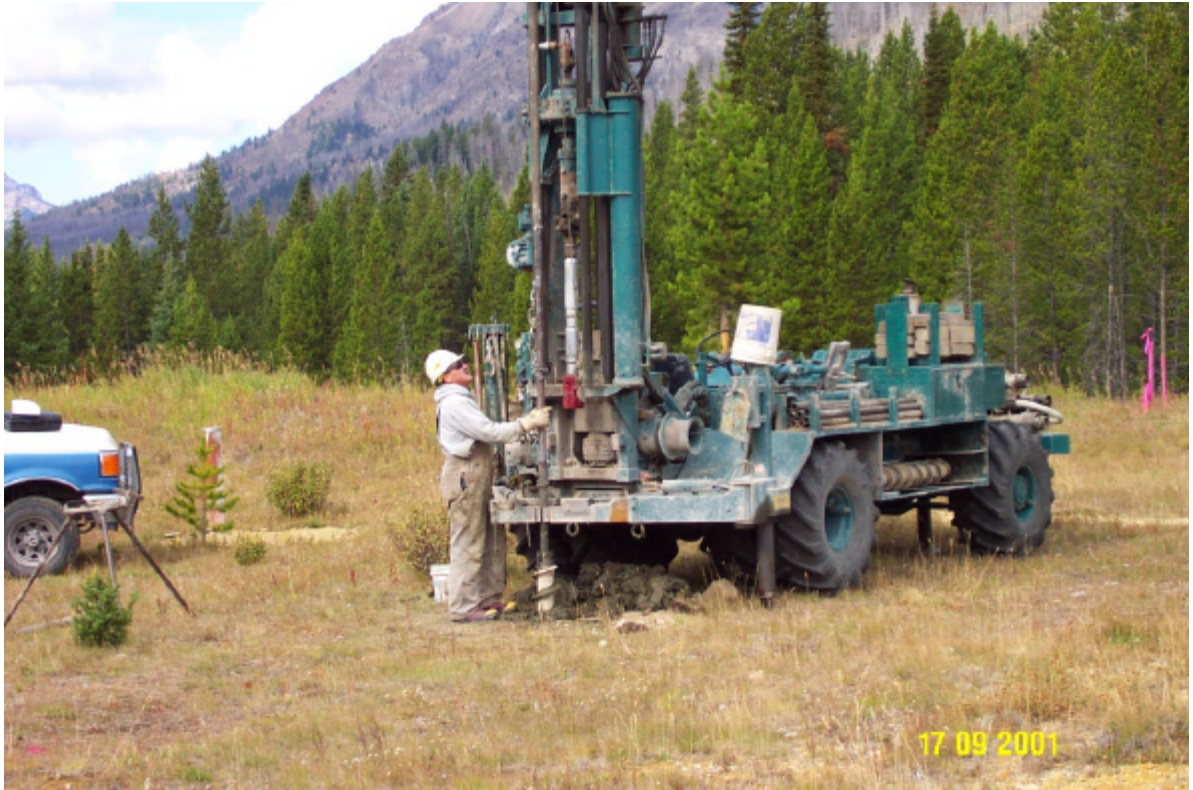
Photo 7: Boring #7, view is towards the west with impoundment dam on the other side of the drill rig.

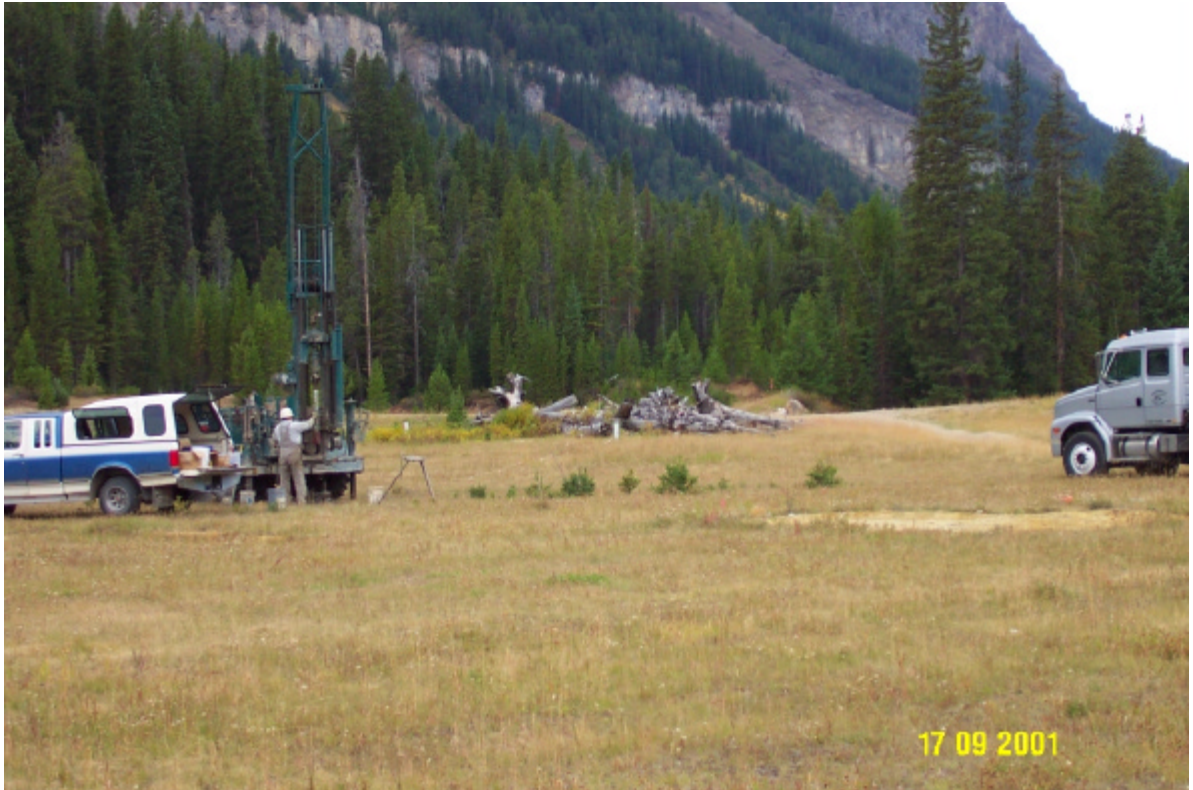
Photo 9: Boring #9, view is to the south. Southern end of impoundment dam is visible at mid-photo to the right.

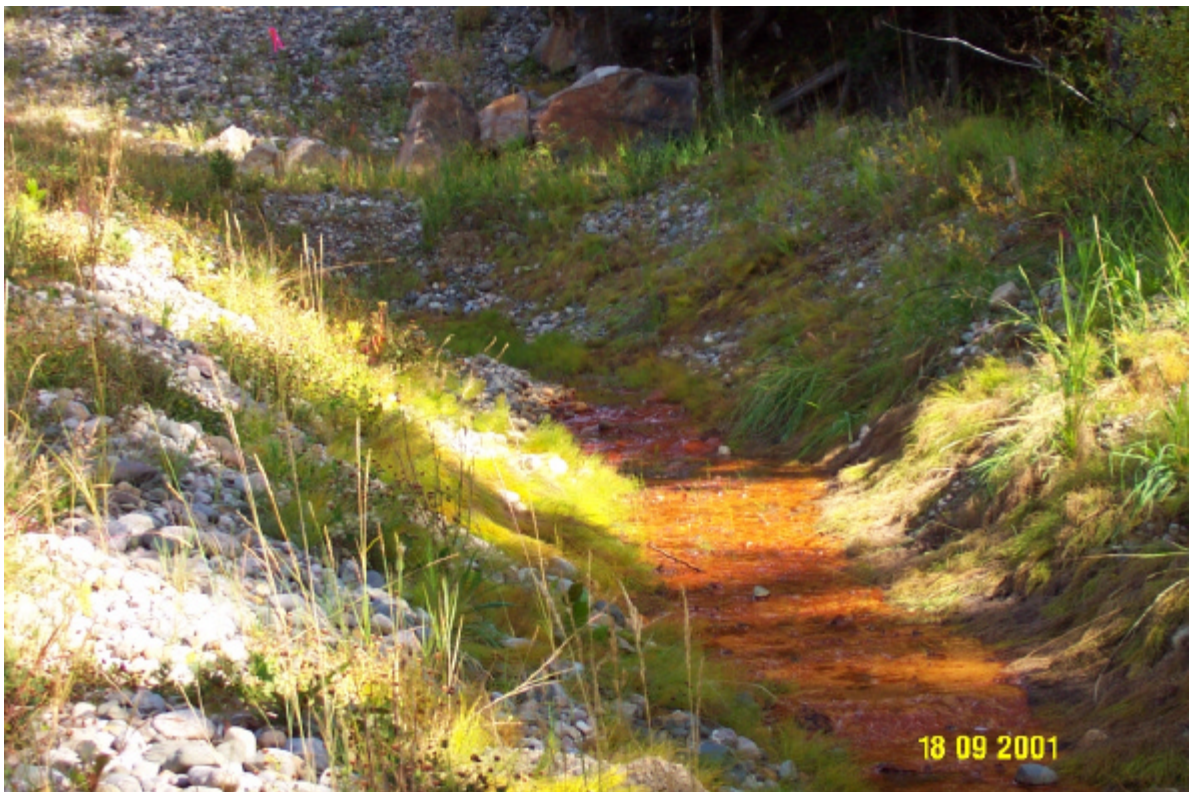
Photo 10: Flow from toe drain at southern end of impoundment dam.
